# Grease Duct

**Inspecting for Liquid Tight Requires Water Test**

*April 2018*

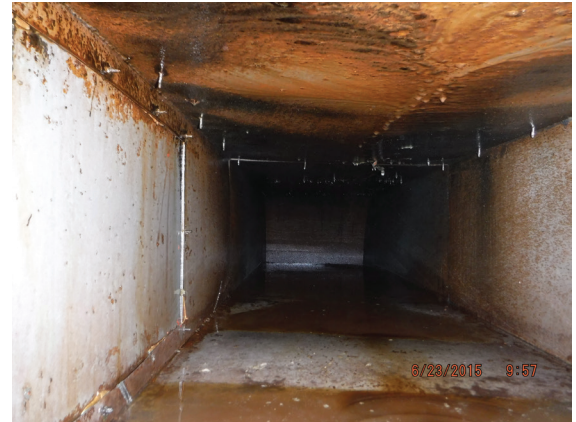
Square kitchen exhaust duct that has been screwed together in lieu of welding, opening the door for leaks through seams and screw holes. Photo courtesy of Derby Pressure Wash, Louisville, KY

Leaks in field-welded ducts are almost always due to improper installation and/or imperfect welds made at the jobsite. Joints, seams and penetration of grease duct are required to have continuous welds to prevent grease and residue from leaking from the duct interior. But workmanship, jobsite conditions and often unfamiliarity of the codes leave many owners with kitchen exhaust systems that will create problems and expense down the road.

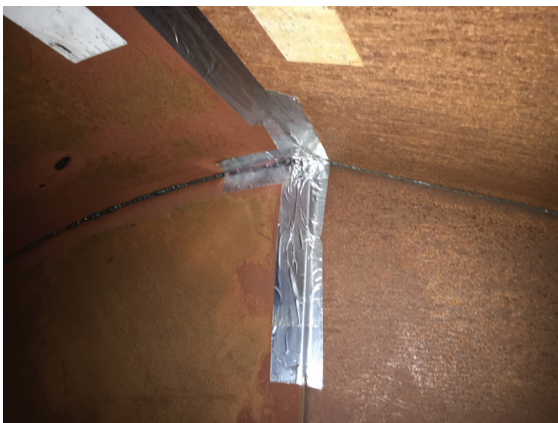
Grease duct seams inappropriately covered with duct tape (typically used for residential clothes dryer exhaust duct), presumably applied to pass a leak test. Photo courtesy of Derby Pressure Wash, Louisville, KY

Finally, sometimes a false pass is not so innocent. Installers have been known to smear flux, silicone and/or epoxy seal over weld joints or place a strip of plain old duct tape over a joint in order to pass a light or smoke test. All of these are quick fixes that will eventually fail.
