Factory-Built Grease Duct

New Code, Historic Downtown Building How Restaurant Rehab Incorporates Factory- and Field-Fabricated Grease Duct to Solve Code and Space Issues.

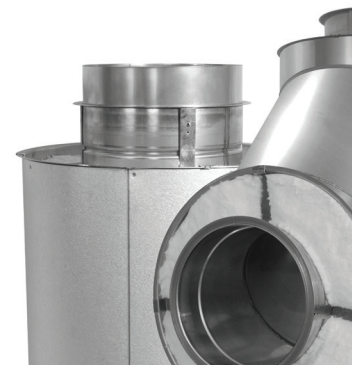
Factory-built grease duct eliminates most, if not all, of job site welding. The systems are modular in design and easily assembled. Instead of welding, components fit together with bands and are made liquid-tight by use of a special sealant. Factory-built systems also include leak-proof, fire-tight access doors, which are required

for regular duct cleaning but are often improperly installed or omitted in field-welded systems.

The DuraVent zero clearance (UL 2221 Listed) grease duct that was selected for the Yorgos project is double-wall stainless steel and ships pre-insulated from the factory, so no additional fire wrap is required to achieve its two-hour fire rating. The product is certified to UL 1978 “Grease Ducts for Restaurant Cooking Appliances” and UL 2221 “Standard for Tests of Fire Resistive Grease Duct Enclosure Assemblies.” DuraVent grease duct also includes a unique centering sleeve that stabilizes the tubes during assembly and covers joint grooves that might otherwise trap grease contaminants. This sleeve offers additional support during installation, and often requires less manpower to hold the duct in position while the sealant is applied.

O'Shea is referring to the extra-large spacing between the outer wall sections of DuraVent's zero clearance grease duct. The extra space and a unique flanged design provides workers with more room to insert the insulation and then attach the outer band with bolts without cutting their hands on sharp metal. This feature alone can save installers a significant amount of time and aggravation on large jobs.

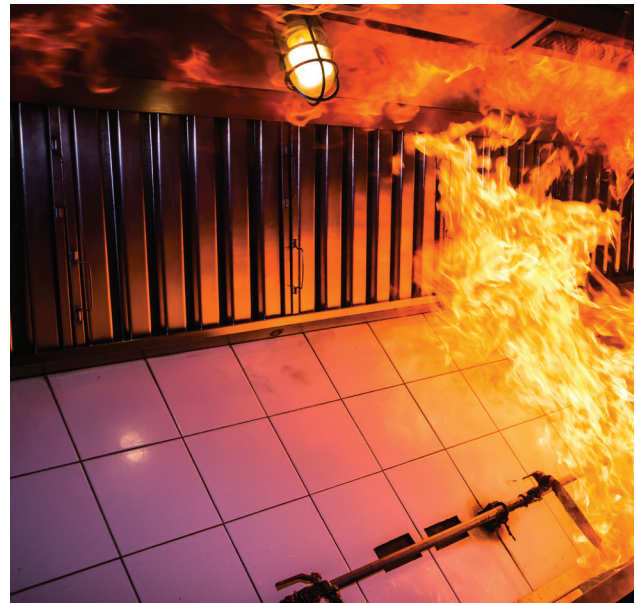
Services, Inc., the mechanical contractor, to design transitional pieces between the factory-built duct and a limited amount of field-welded rectangular duct, which can be constructed with a lower profile. Ordinarily field-welded duct would not be allowed in a new or renovated Lancaster building because of the previously mentioned ordinance. However, because making the round duct fit in certain areas of the basement and above the top floor ceiling would involve extensive structural modifications to the building, the construction team (with the help of the third-party inspector) sought and was granted permission from the City of Lancaster to install limited runs of field-weld duct.

Clark fabricated the transitional pieces in its shop according to DuraVent’s design, along with the necessary rectangular sections of duct. All the duct

sections, welded and factory-built, were pre-tested for leaks in the shop using a light test administered by the code inspector under full blackout conditions. Once the complete system was installed, a smoke test was administered at the jobsite to detect any joint leaks. For more information on leak testing, reference DuraVent's leak testing white paper.
